CARR-1572 St. Paul's Reformed Church Bond Street at Green Street, Westminster Private 1868-69; 1893; 1923

Maryland Historical Trust State Historic Sites Inventory Form

CARR-1572

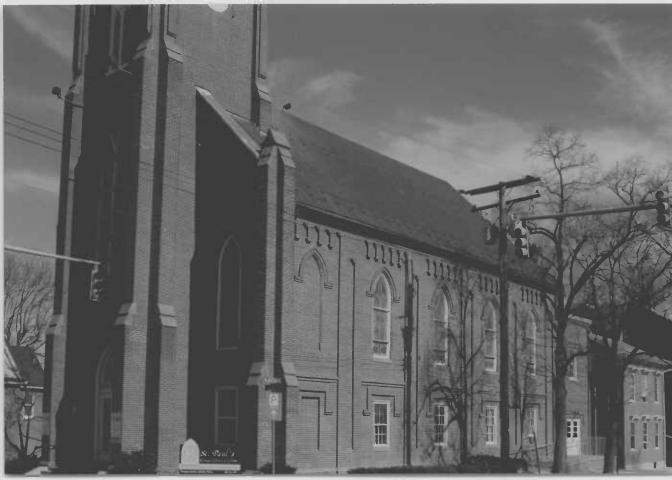
ST. Paulo Reformed Church Bond & Green STS. Carroll County Maryland Photo: Kenneth H. dhork Data: March 1998 Neg Loc: Maryland Historical Trust NEW Elens

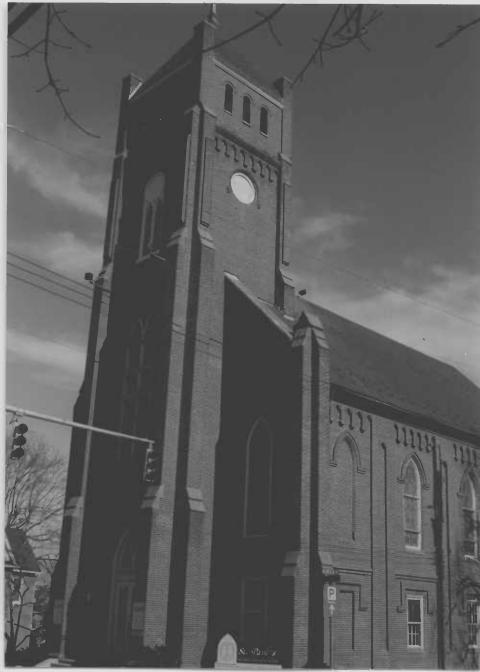
Carr-1572

ST. Paul's Reformed Church
Bond & Green Sts
Westminster
Carriele Country Maryland
Photo: Kennesh M. Whort
Date: March 1998
Neg Loc: Maryland Bustonical Trust
NEW Elevs

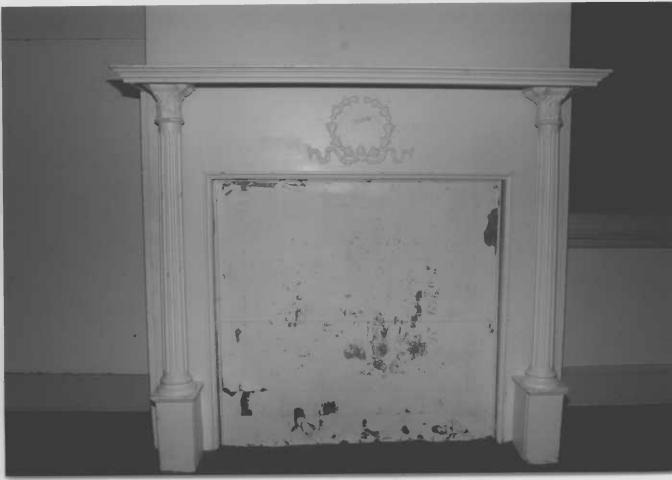
Carr-1572

ST. Pauls Ryormed Church Bond & Sheen STS Westminster Royer Howar - NW RM Martel Carriel Courty Maryland Photo: Kenneth M. Whork Date: March 1998 Neg Loc: Maryland Historical Trust

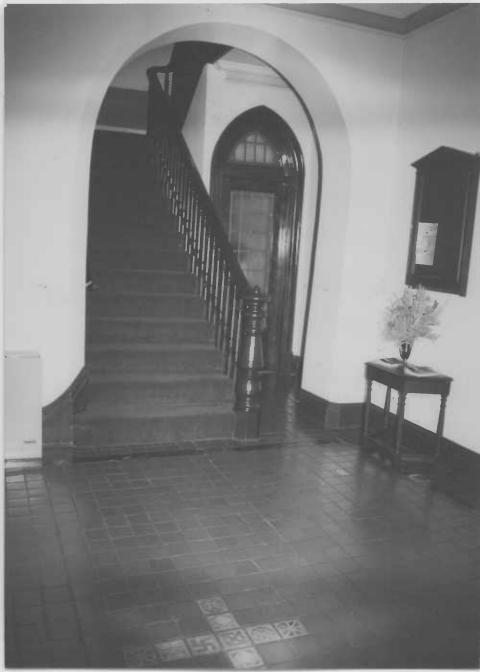
Car 1572

ST. Paul's Ryarmed Church Bord & Druin Sts Westmuster Carnoll Courty Maryland Photo: Kennich M. Ethort Date: March 1998 Negra: Maryland Historical Trust Lower story Vestibule & Stari

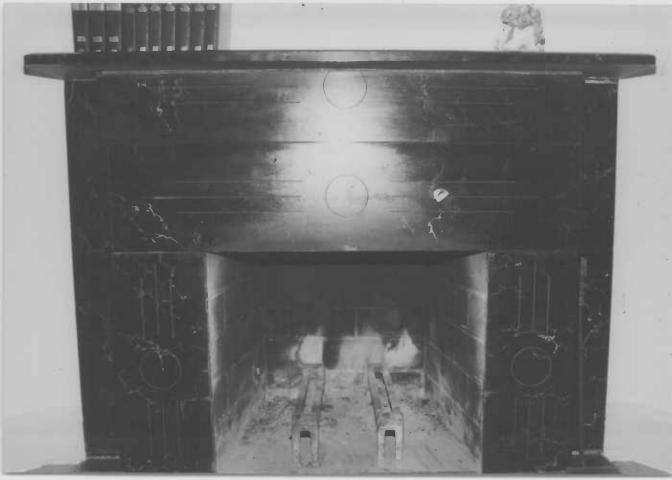
Car -1572

ST. Paulo Ryonmed Church Bond & Sheen Sts Westmurster Carroll County Maryland Photo: Kenneth M. Johnort Date! March 1998 Nigloc! Maryland Historical Trust Parsonage-NW RM. Martel

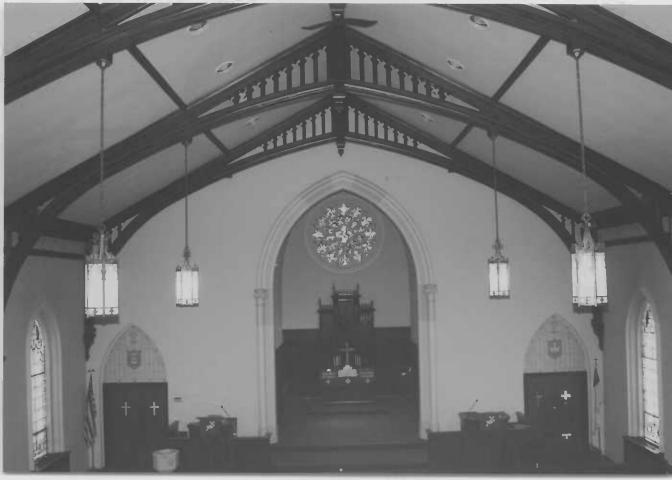
ST. Paul's Reformed Church Bond & Sheen Sts, Westmirster Carrell County Maryland Photo: Kurreth M. Johnt Date: March 1998 Neg Loc: Manyland Historical Trust Nave - VW. S

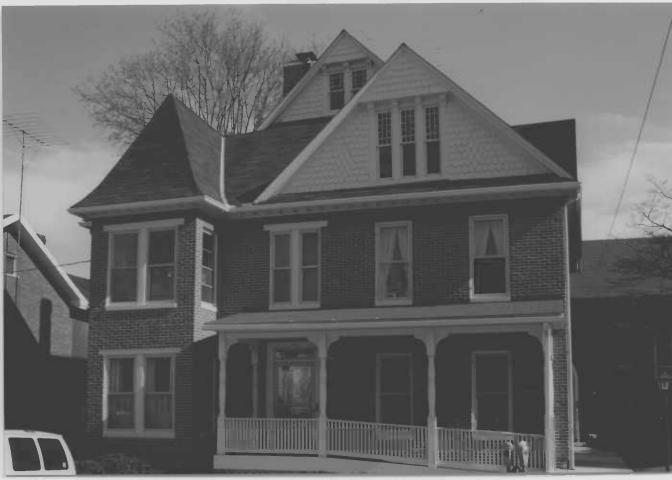
ST. Pauls Reformed Church Bond & Green Sts, Westminster Carroll County Maryland Photo: Kennah M. Whork Date: March 1998 Personage - N. Elev

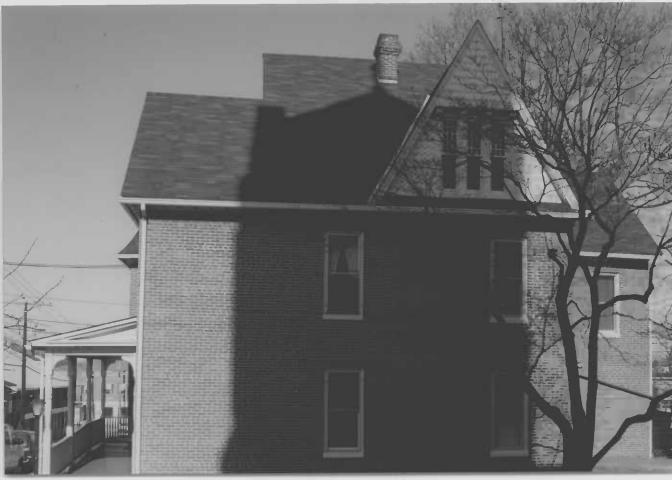
CARR-1572

ST. Pauls Reformed Church Bond & Sheen Sts, Westmurden Carroll Country Maryland Photo: Kenneth M advort Date: March 1998 Meg Loc: Maryland Midducial Trust Parsonage - W. Elw
